Submission to:

A.C.T. Environment, Planning and Sustainable Development Directorate – Planning

**Re: Development Application number: 202240445**

(Umbagog Bridges, Umbagog District Park, Florey Drive, Latham)

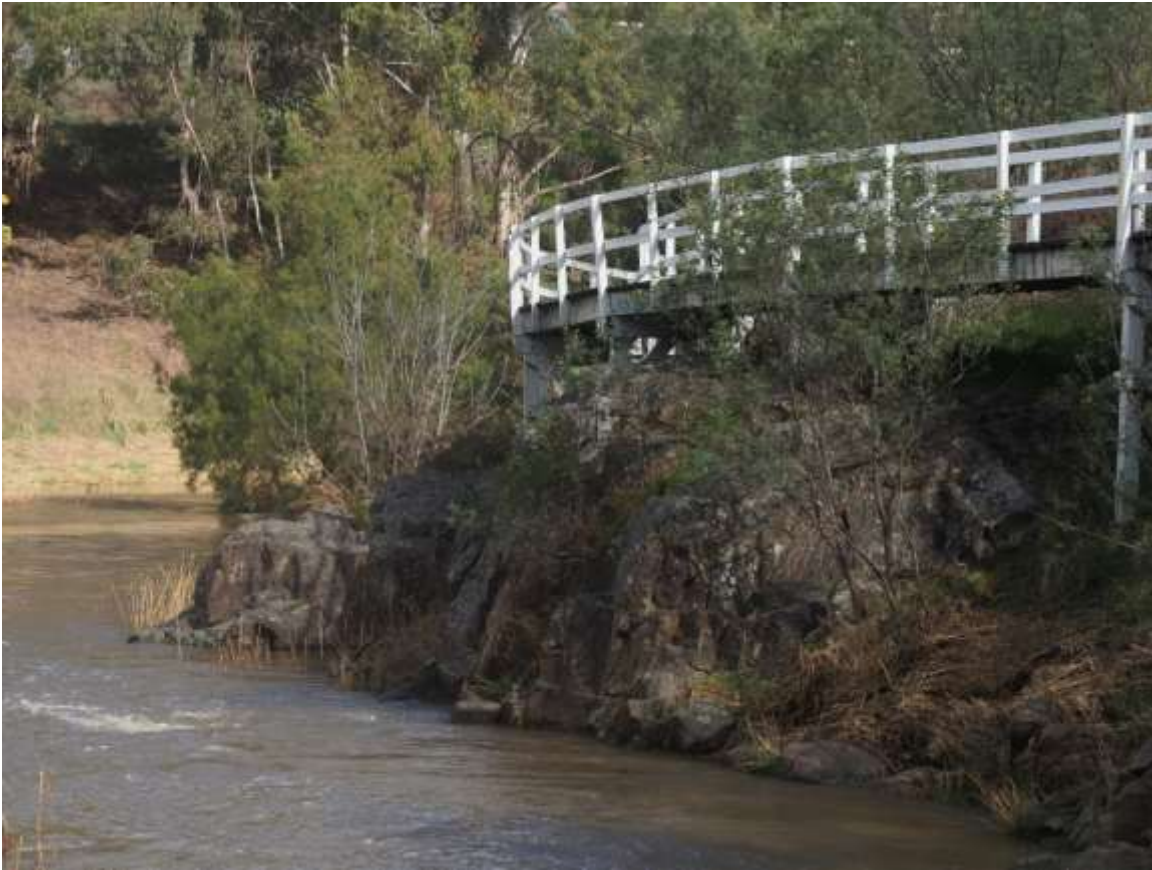
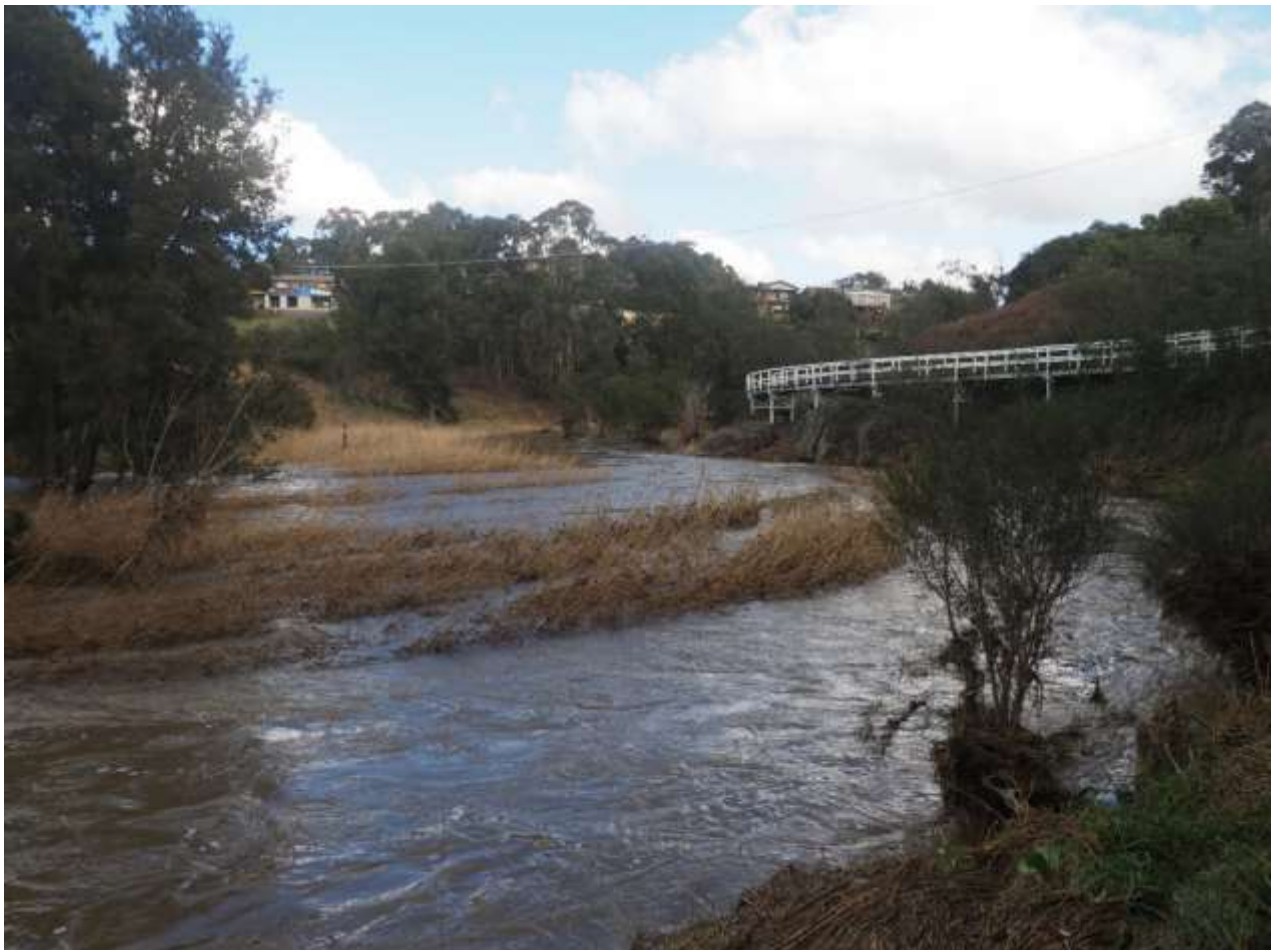
### Photos 1 & 2: Footings spacing

Existing bridge 1193 have a longitudinal footing spacing of 4m

The footings of the existing wooden bridges are spaced 4m apart (longitudinally). See Photos 1 and 2.

The design documents submitted with the DA ('Landscape Plan.01, .02, .03', drawings L400, L401, L402 and elevation drawing L700) indicate that the footings of the new design will be a mere 1.8m apart, both latitudinally and longitudinally (if measured using the drawing scale). This means that while the new modular bridges are said to be 'lightweight' they appear to require twice the support of the existing heavy timber bridges.

This number of footings would create twice the amount of disturbance to the land below the bridges as footings with the current 4m spacing. While invisible and below the surface in the case of the two swamp bridges (1194; 1195), the footings involve significant amounts of concrete (e.g., detail plan option 1 of drawing L722) involves a concrete block of 500mm W x 1800mm L x 500mm D). We would prefer footing options that cause minimal disturbance.

The Rocky Outcrop is a sensitive biodiversity area and a breeding area for Cunningham skinks and Eastern Water dragons (see Photos 27-31), hence the disturbance of the rocks (digging, drilling and especially concreting) should be kept to a minimum. Reusing the existing 4m-spaced footings would be by far the best solution.

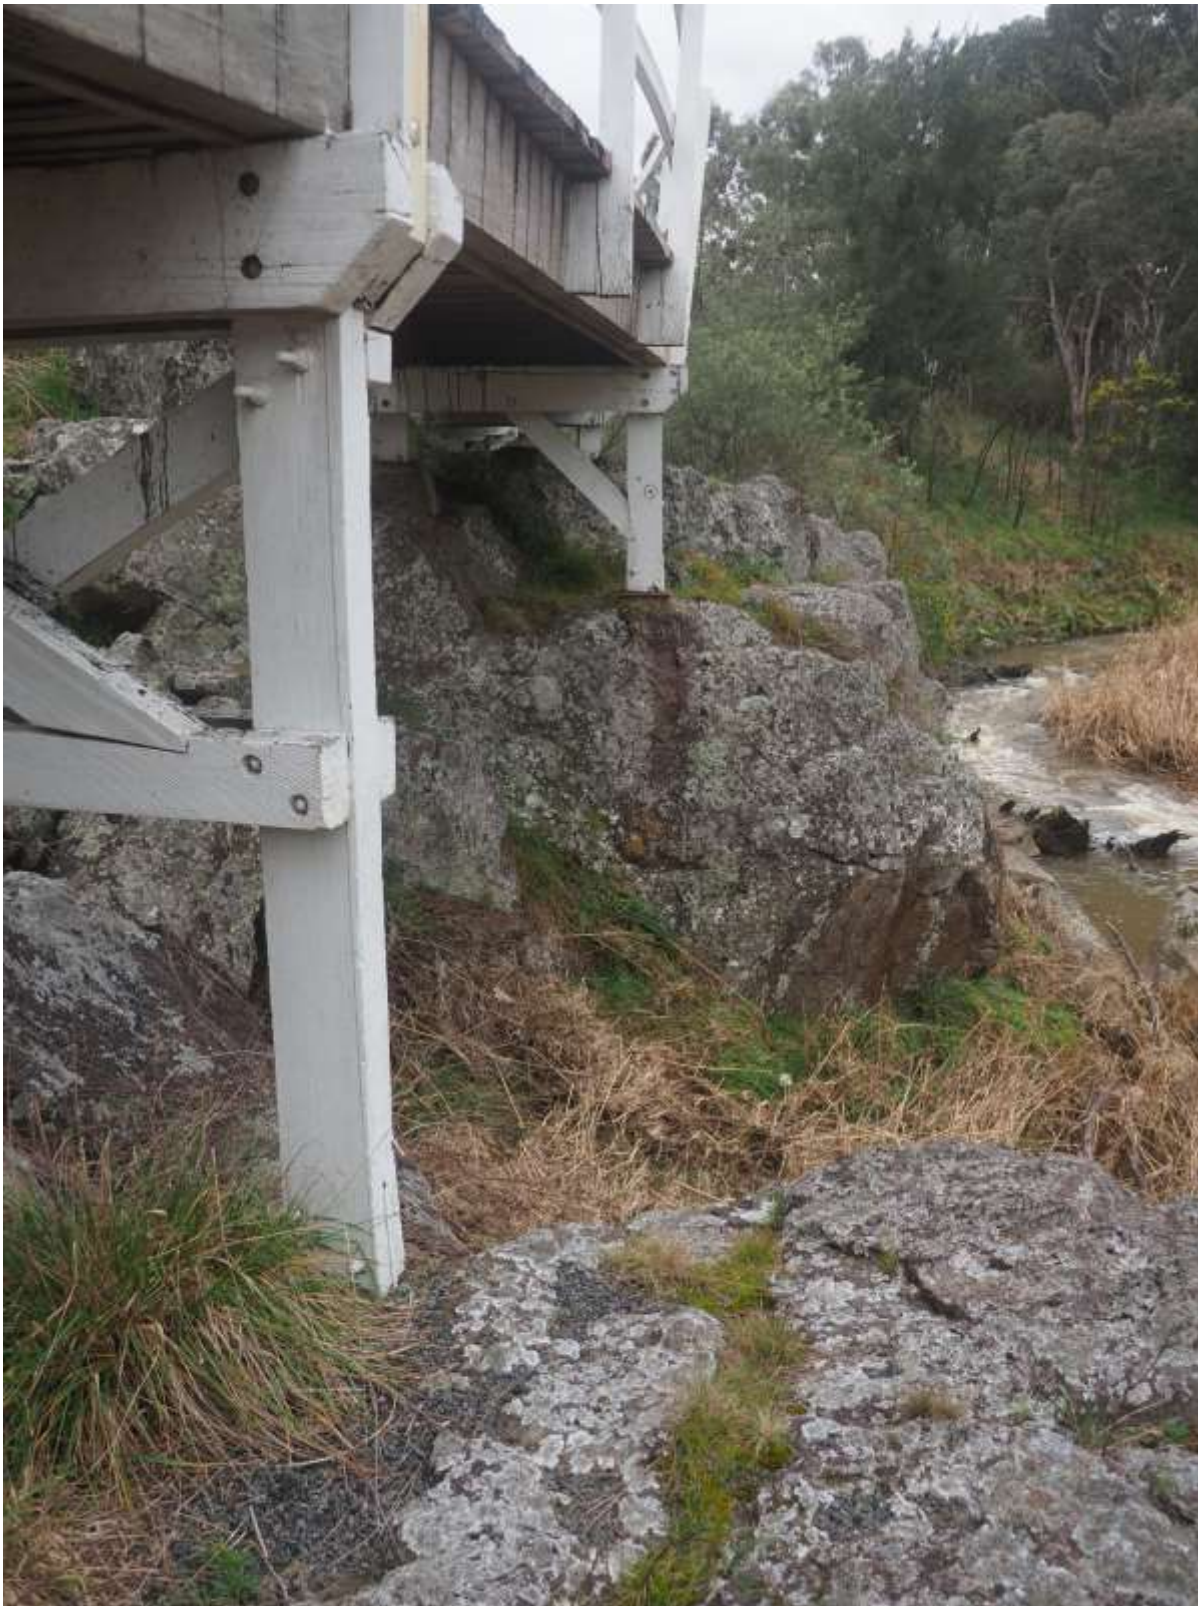
**Photo 3: Footings attachment**

The majority of existing footings are bolted directly into strong volcanic rock without need for concrete. Concrete footings were only required for a few spots in the existing bridge.

The existing footings of bridge 1193 are in many instances bolted directly into the rock, requiring no concrete (see Photo 3). The Rocky Outcrop is made of volcanic rock, and it is stronger than concrete.

It is likely that the DA diagrams are simply not sufficiently detailed and that the bridge designers plan to bolt footings directly into the rock where possible. If this is the case we would welcome clarification and additional detail on this.

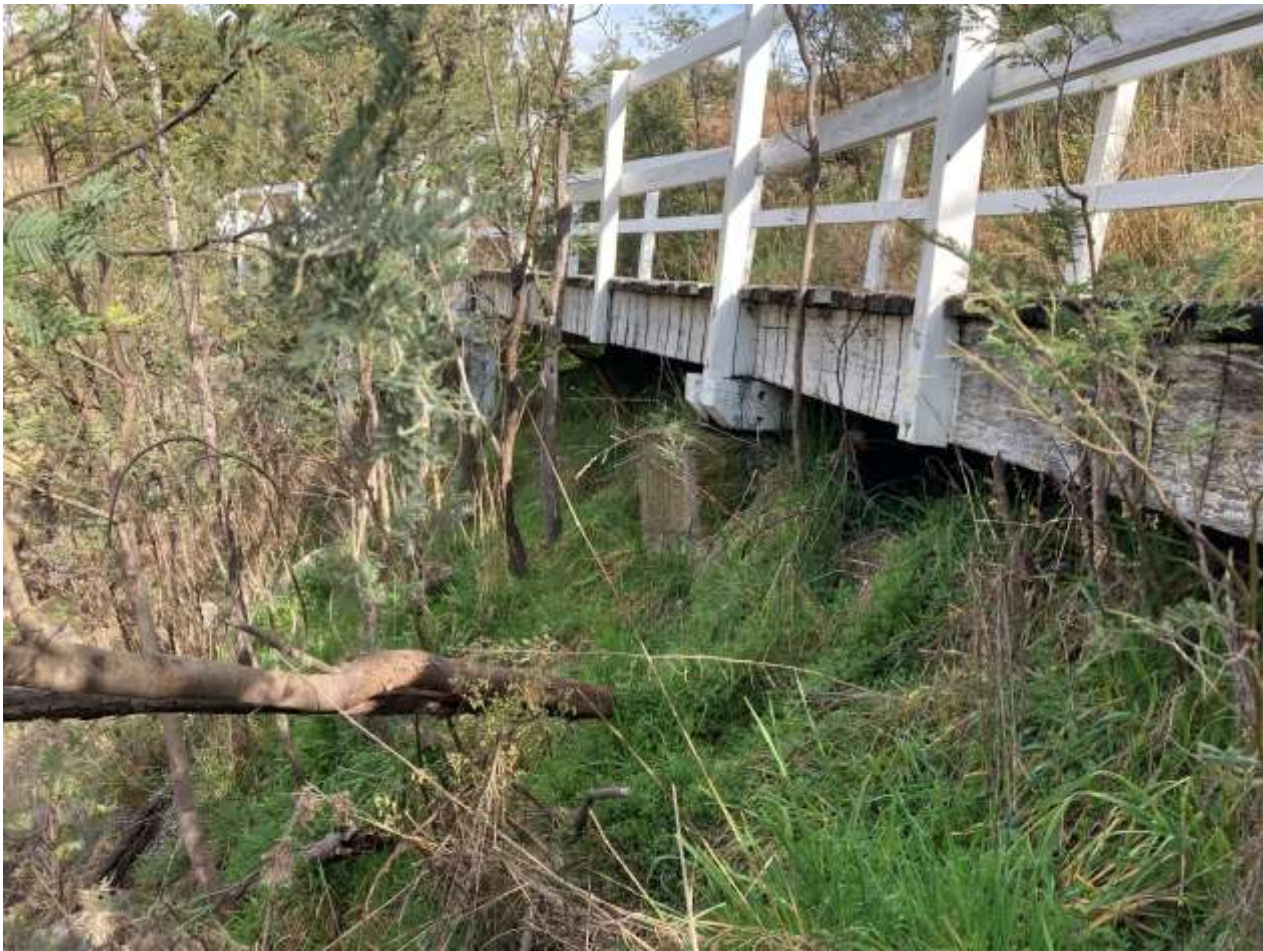
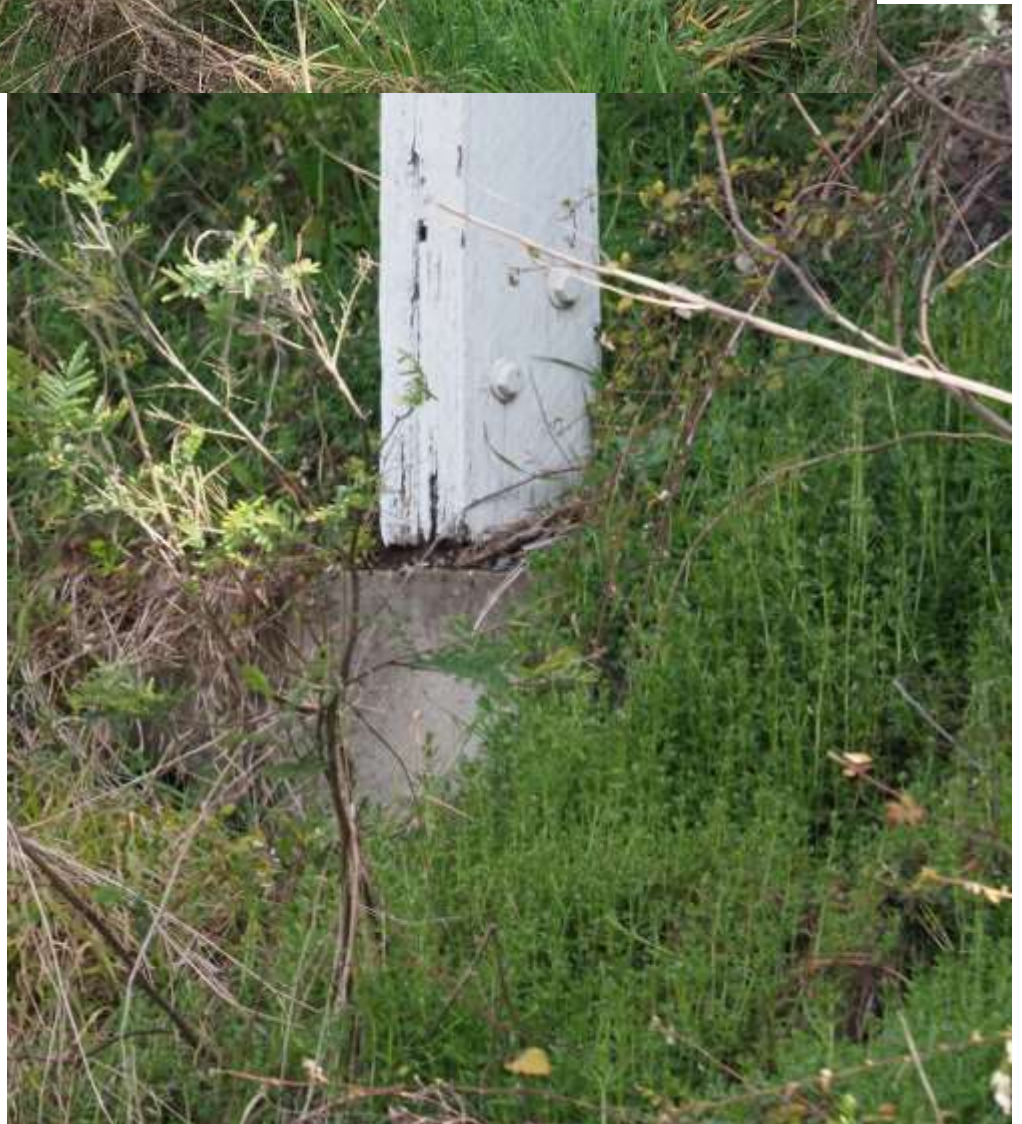
**Photos 4 & 5:** Existing concrete footings where bolting direct into rock was not feasible

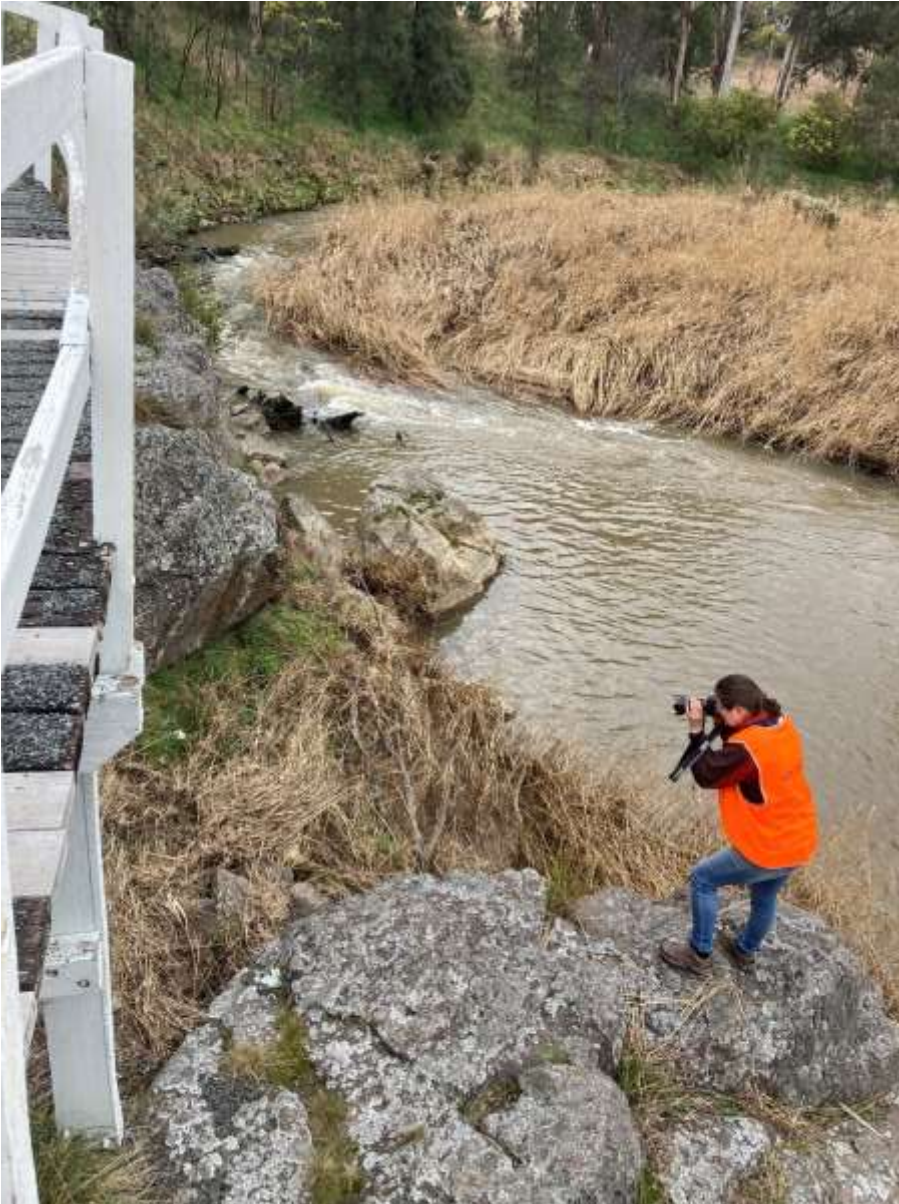
**Photo 6: Viewing Platform Location**

The rocky platform the photographer is standing on would be completely covered by the proposed ~7m x 2.5m viewing platform. This rock platform is used by basking reptiles.

It would it be better to locate the viewing platform over the scrubby gully between the rocks, an area of little habitat value vegetated with non-native grasses.

Position: The DA design ('Landscape Plan.01', drawing L400) indicates that the viewing platform is currently positioned directly over a large rock ledge used by sunning lizards. It would be better placed over the adjacent 'grassy area' which is of low habitat value (primarily rank exotic grasses). See Photos 6-9.

Size: In keeping with other lookouts like Shepherd's Lookout, the viewing platform only needs to be of modest size, where a few people at a time are able to comfortably see over lower railing. The current design (if measured according to the scale on the drawing) would be 7m long x 2.3m wide (if added to the outside width of the main path, the total width would be 4.7m according to L701). We suggest this is larger than needed and it seems out of scale with the site. A smaller platform would be lower impact (less shading to reptiles), would require fewer footings (only one row), and would hopefully be cheaper.

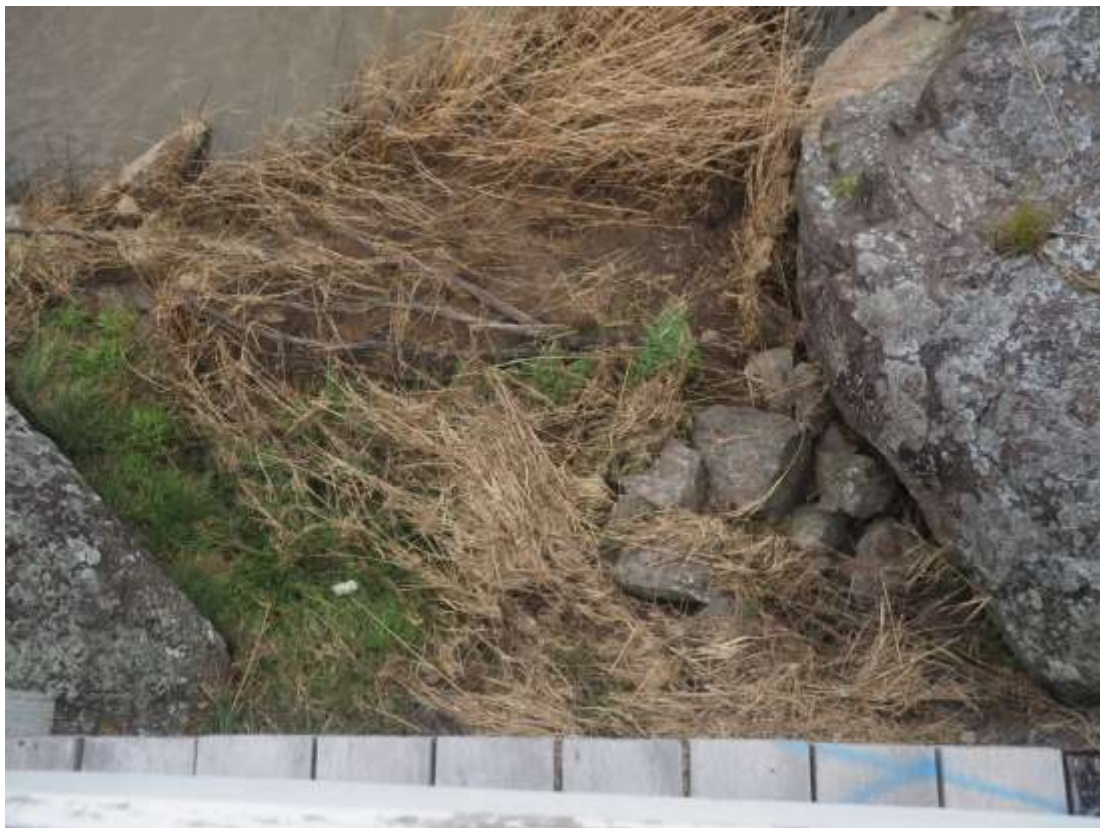
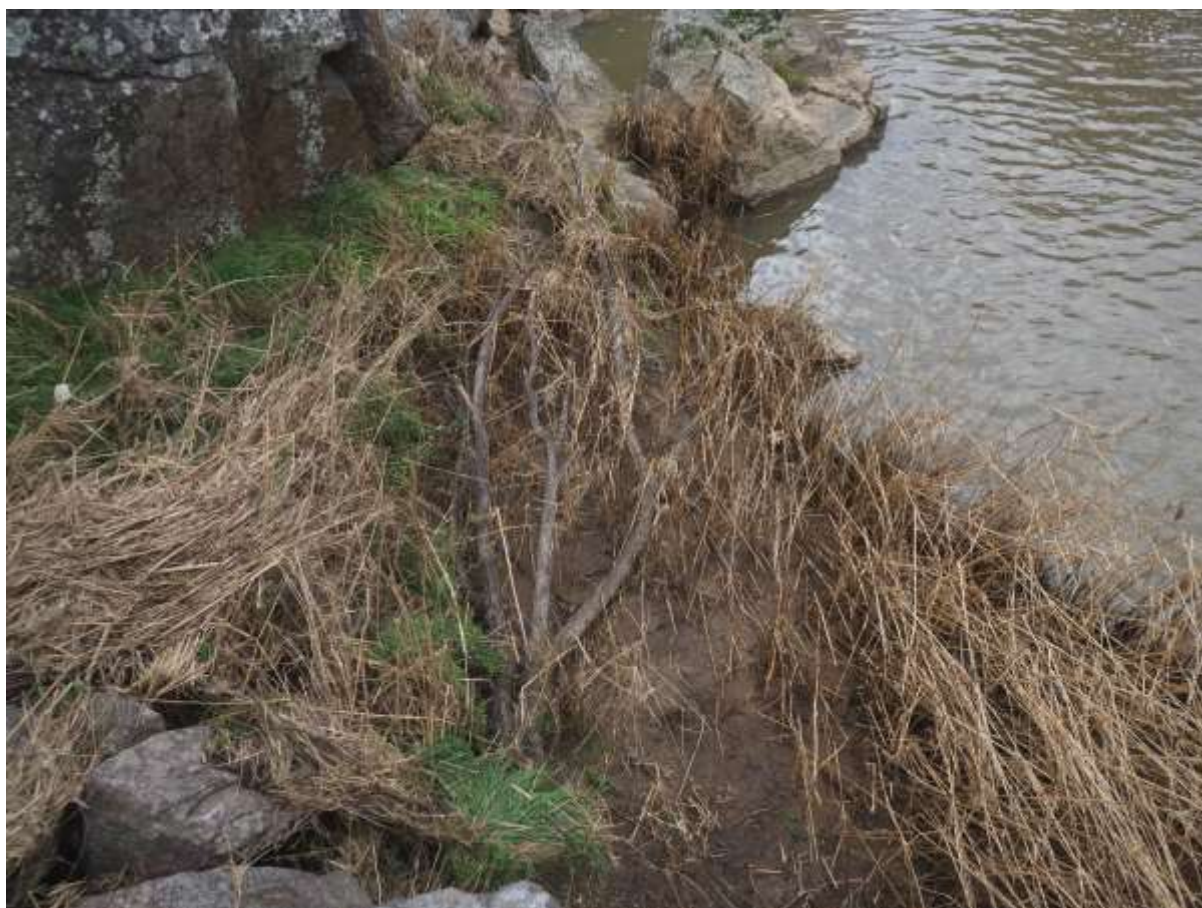
**Photos 7 and 8: Viewing Platform Location**

Scrubby grass between 2 rock outcrops as seen from above on the existing bridge (top) and from the rock platform due to be built over (below)

We suggest a modest sized viewing platform be built over the gully rather than over the rock platforms.

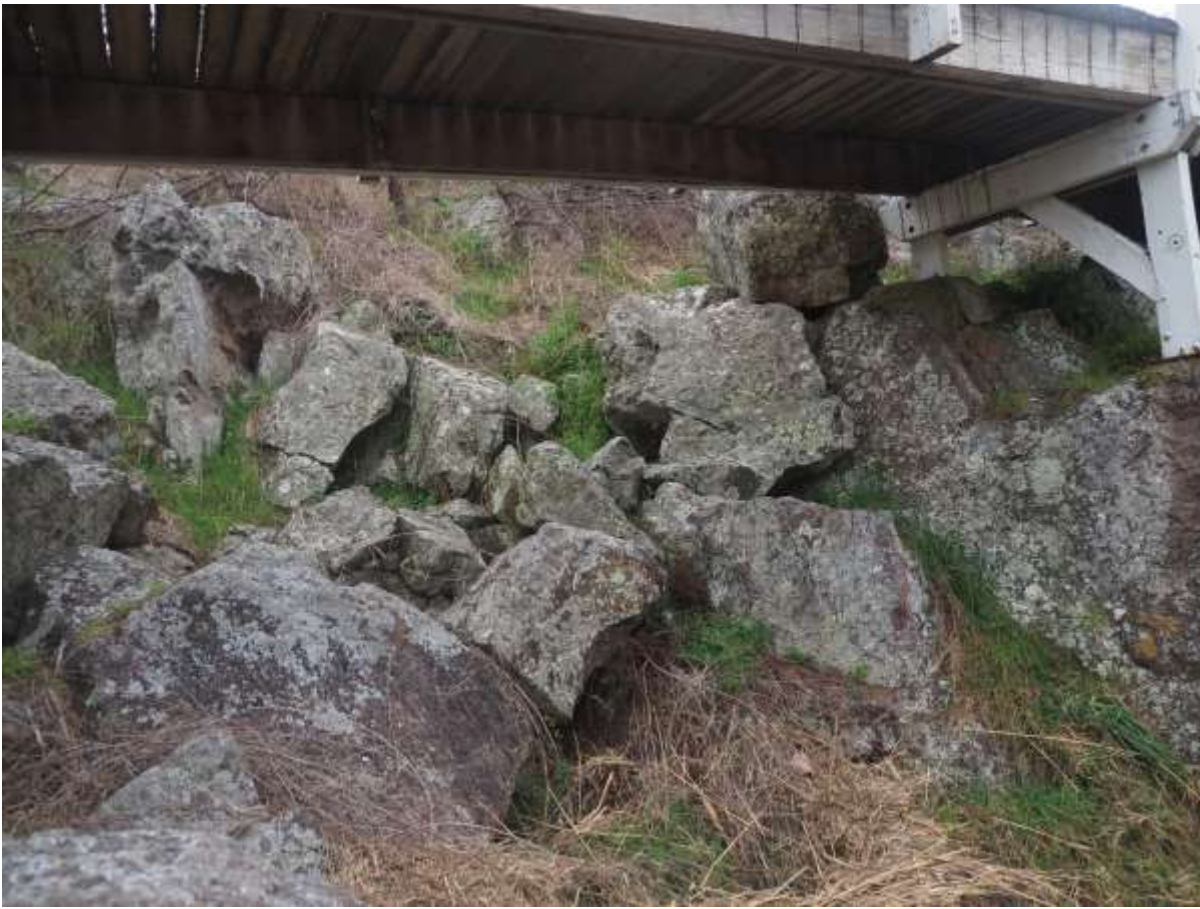
**Photo 9: Viewing Platform Location**

Under the existing bridge at the rock gully spot

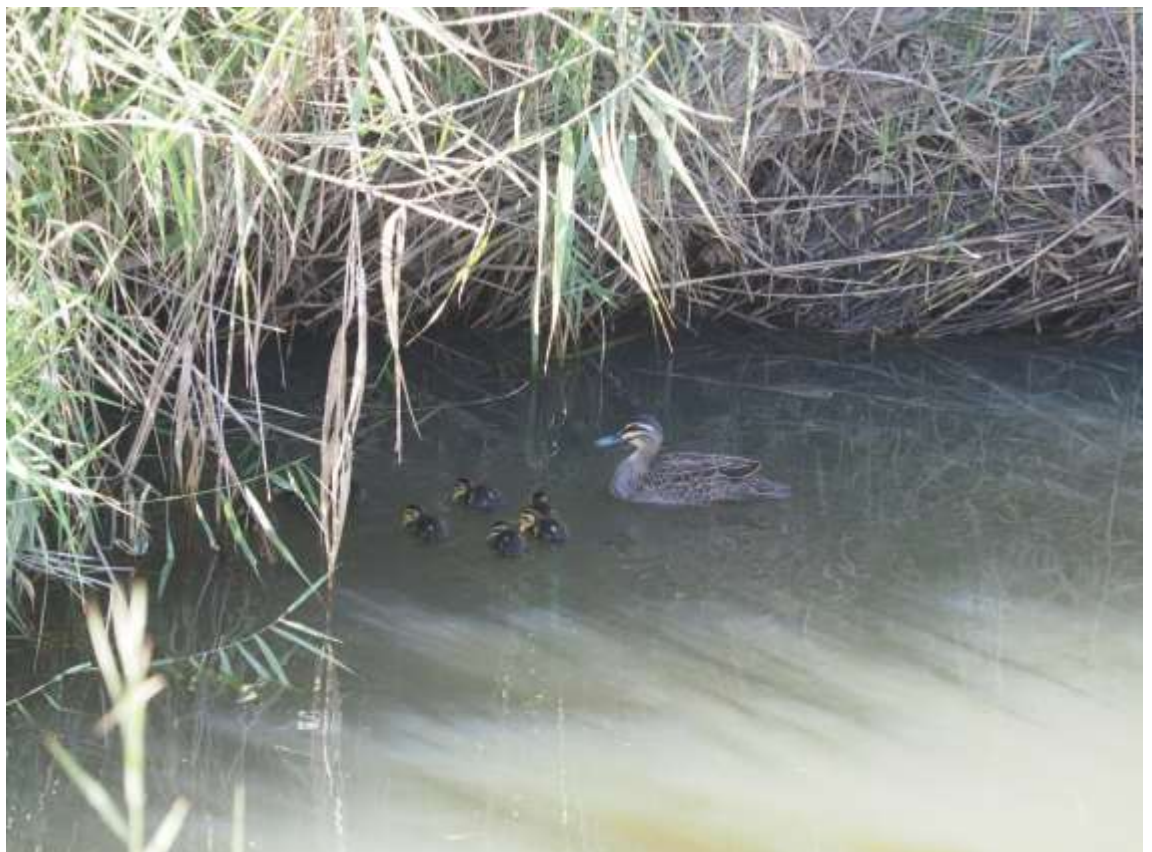
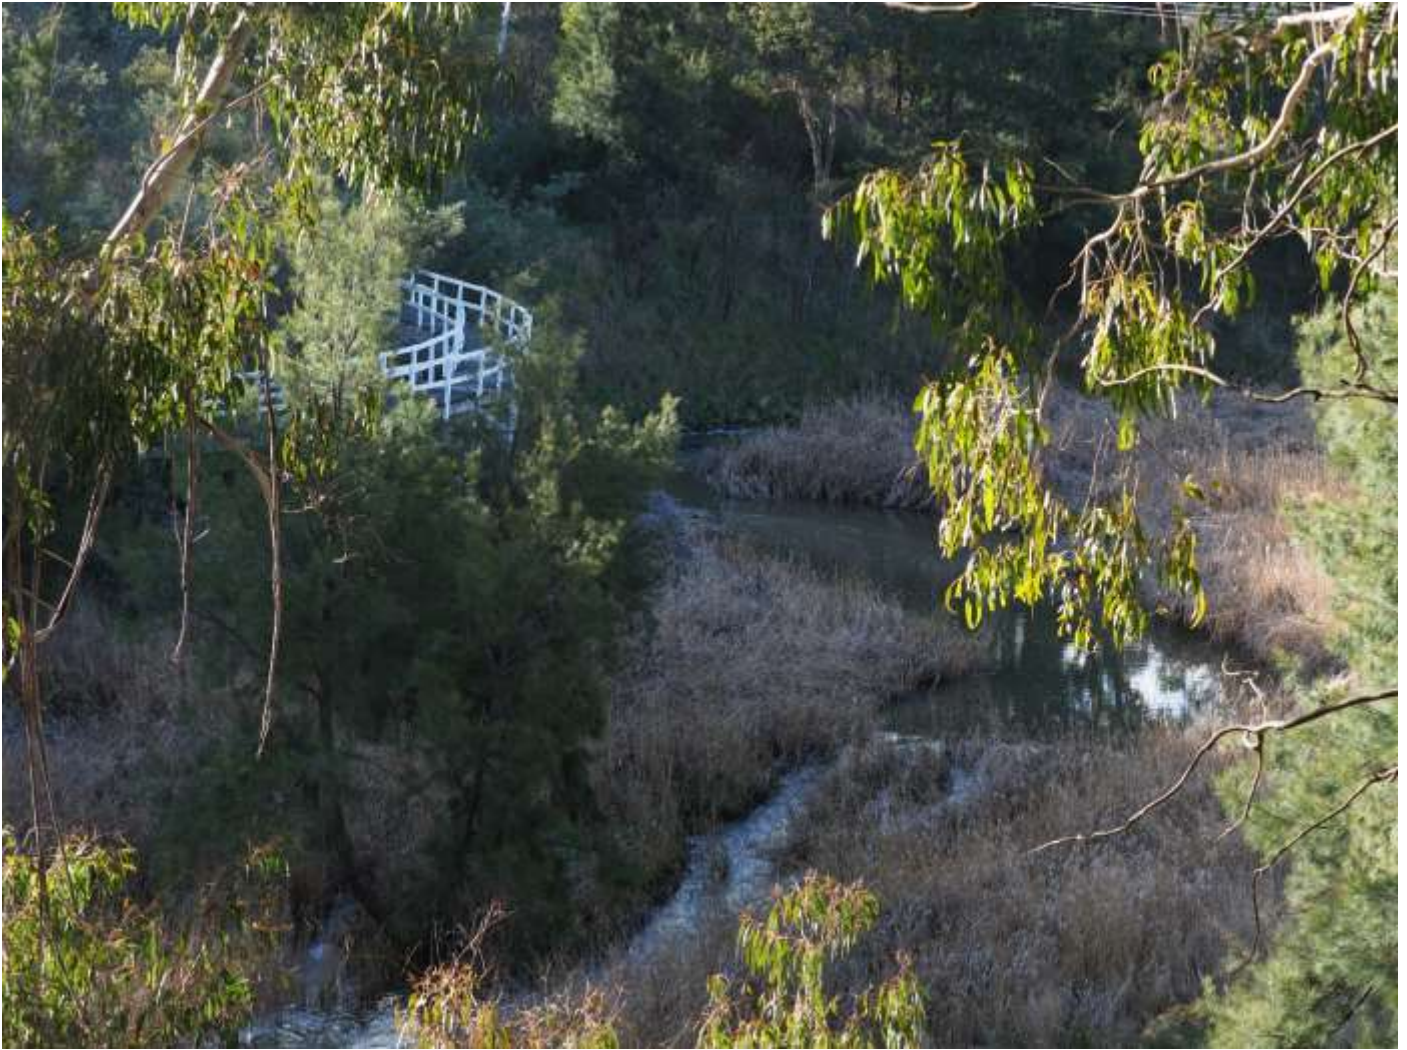
**Photo 38:** The existing Bridge 1193 from the opposite bank
